# Manhole Inspection Summary

Manhole # S47G\_\_019MH

Insp Date: **5/1/08 10:06 AM**

**Location** Address: **202 S Collington Av**

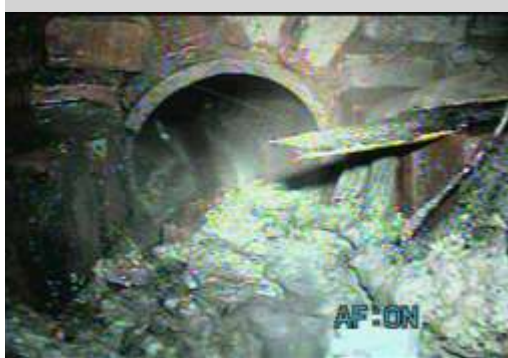
Defect 5

☒ **Debris**

channel debris

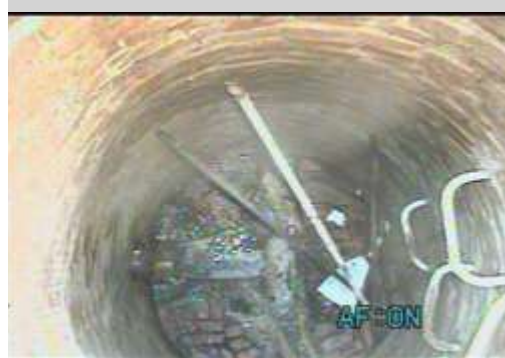
Defect 4

☒ **Debris**

bench debris

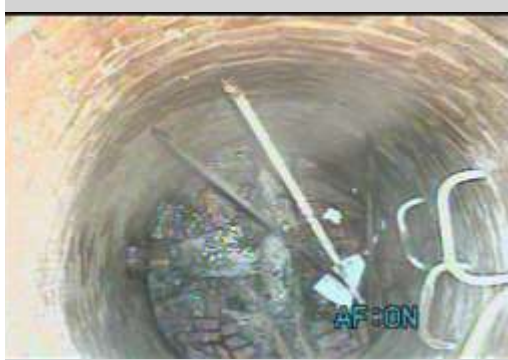
Defect 3

Missing: **1**

☒ **Corroded**

corroded steps

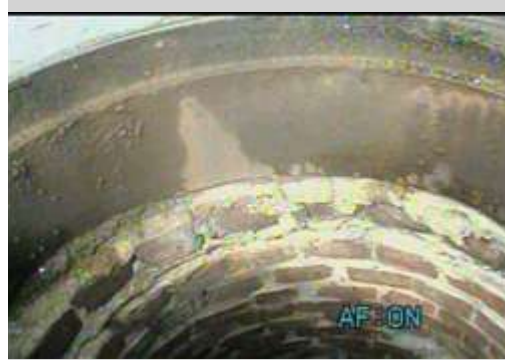
Defect 2

☒ **Leaks**

☒ **Cracked**

chimney cracked and frame leaks, frame adjustment

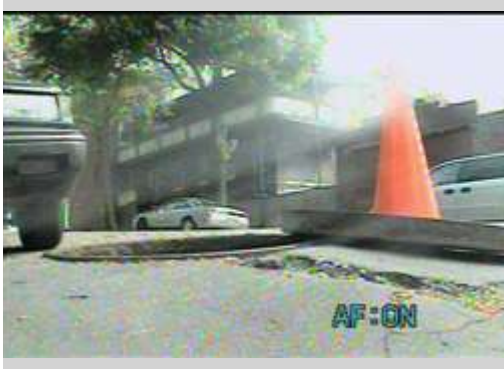
### Defect 1

adove grade

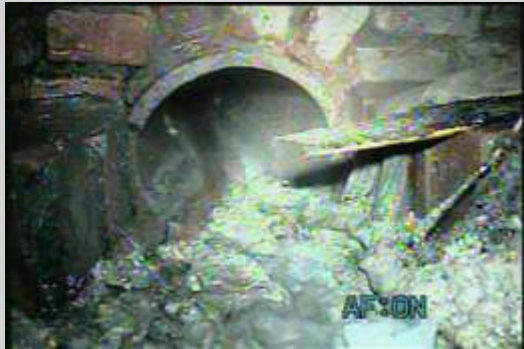
12 O'Clock Outflow

Deposits: ☐ None ☐ Mud ☐ Sludge ☒ **Debris** ☐ Grease

Silt Depth: **1** (in.) Deposits Extent: **Light**

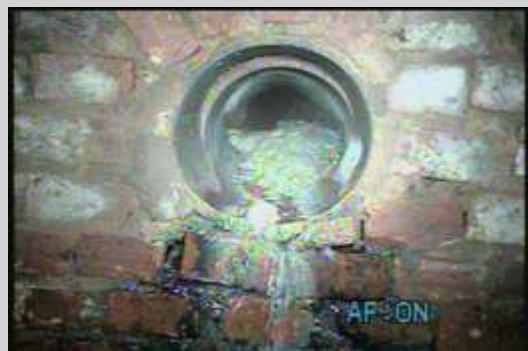
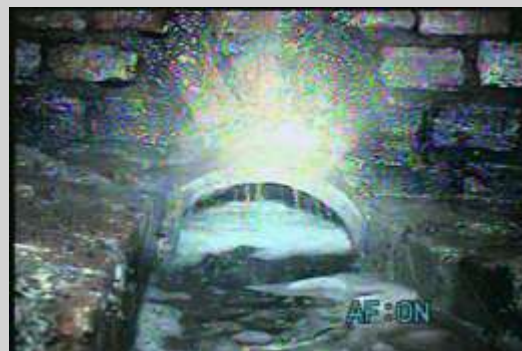
9 O'Clock Inflow

Deposits: ☐ None ☐ Mud ☐ Sludge ☒ **Debris** ☐ Grease

Silt Depth: **4** (in.) Deposits Extent: **Medium**

Drop Condition: **Partly Clogged**
